**A REPORT TO
THE SECRETARY OF THE AIR FORCE**

C-130 Broad Area Review (BAR)

King 56 Salvage

25 August 1998 Addendum
to the 15 January 1998 Report

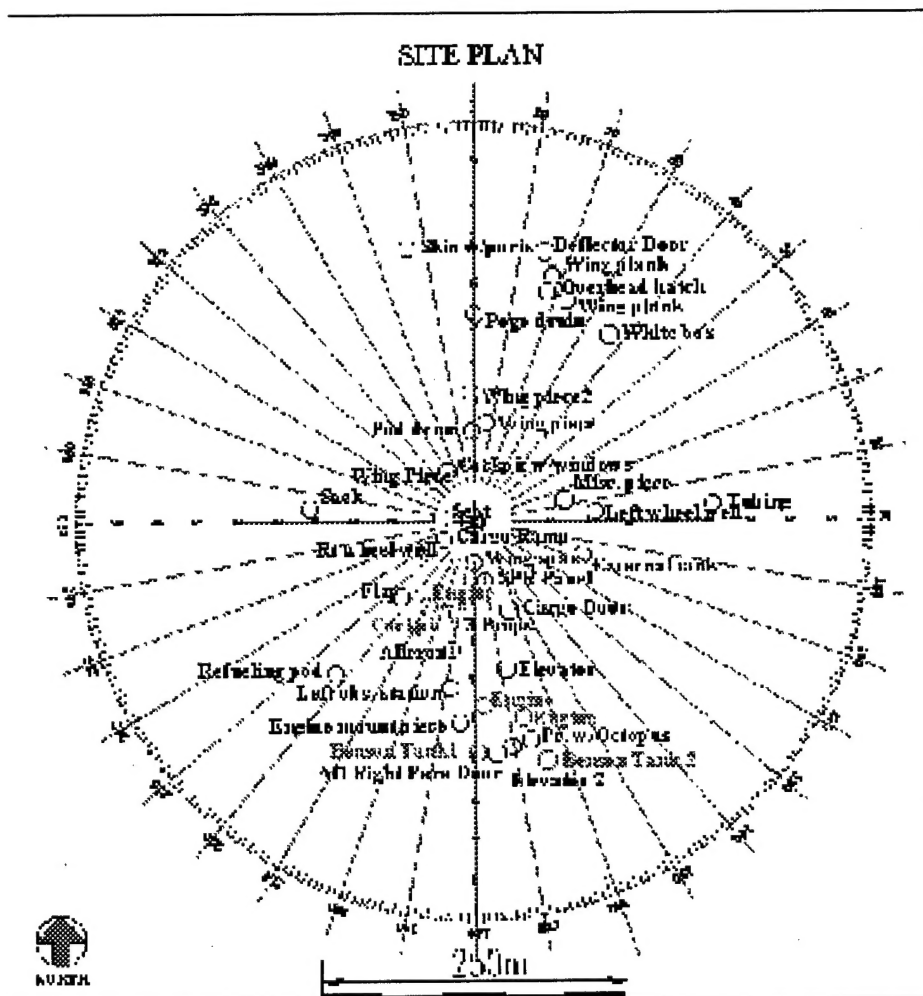
Figure 1-1

US AIR FORCE C-130 "KING 56" DEBRIS RECOVERY

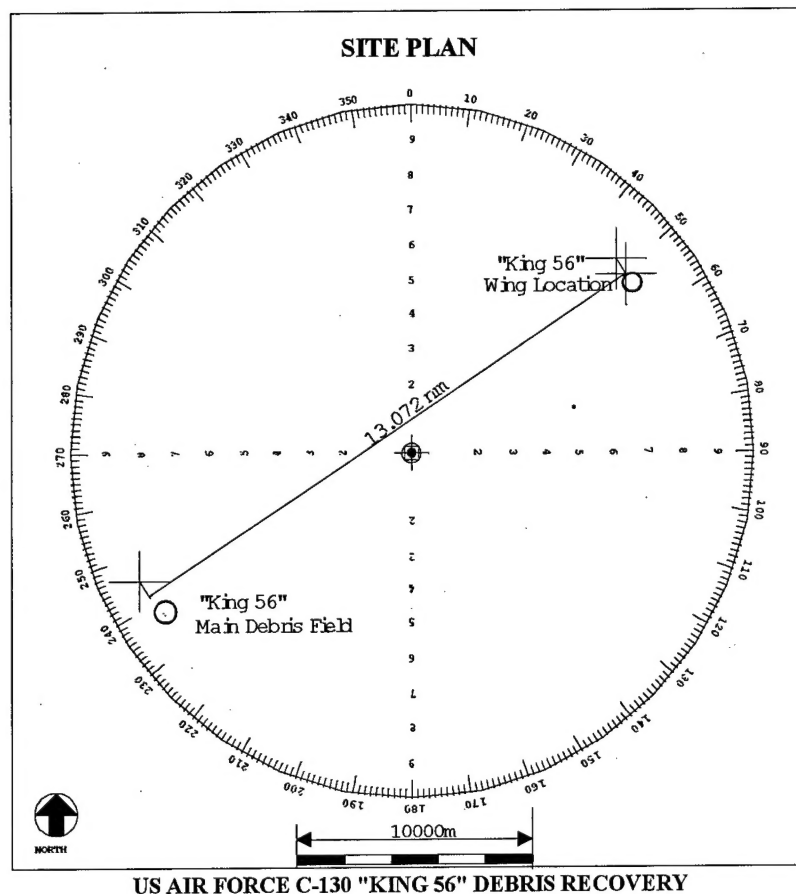
Figure 1-2

US AIR FORCE C-130 "KING 56" DEBRIS RECOVERY

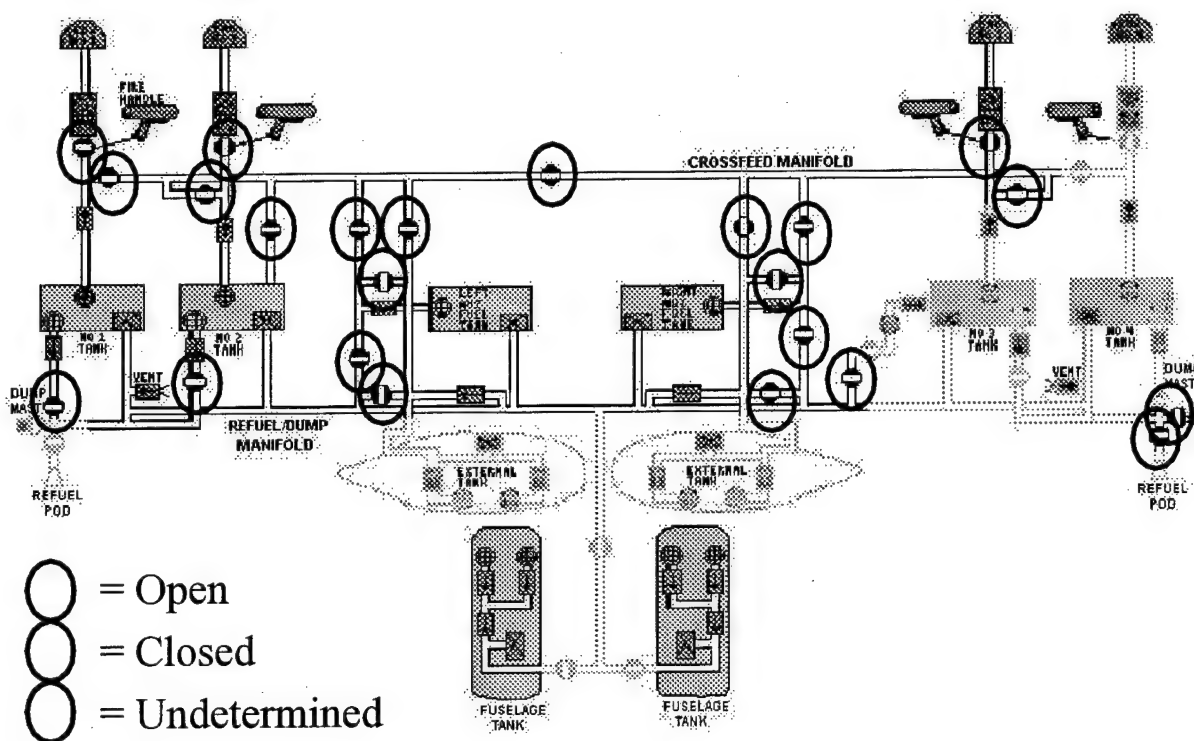
Valve Positions from Recovered Wreckage

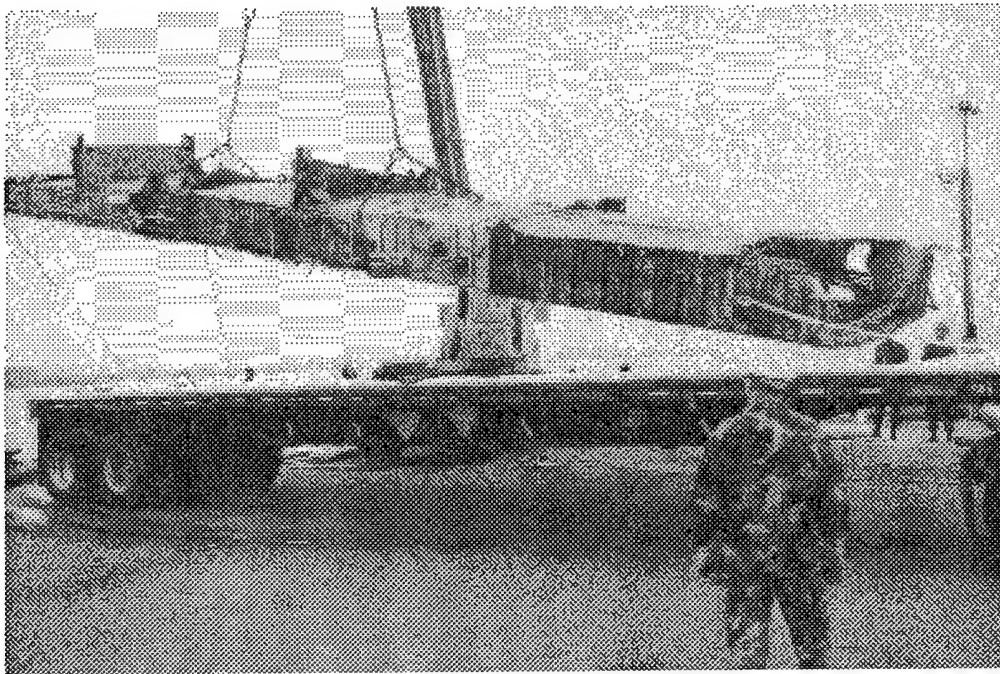
Center Wing Section Being Loaded for Transport

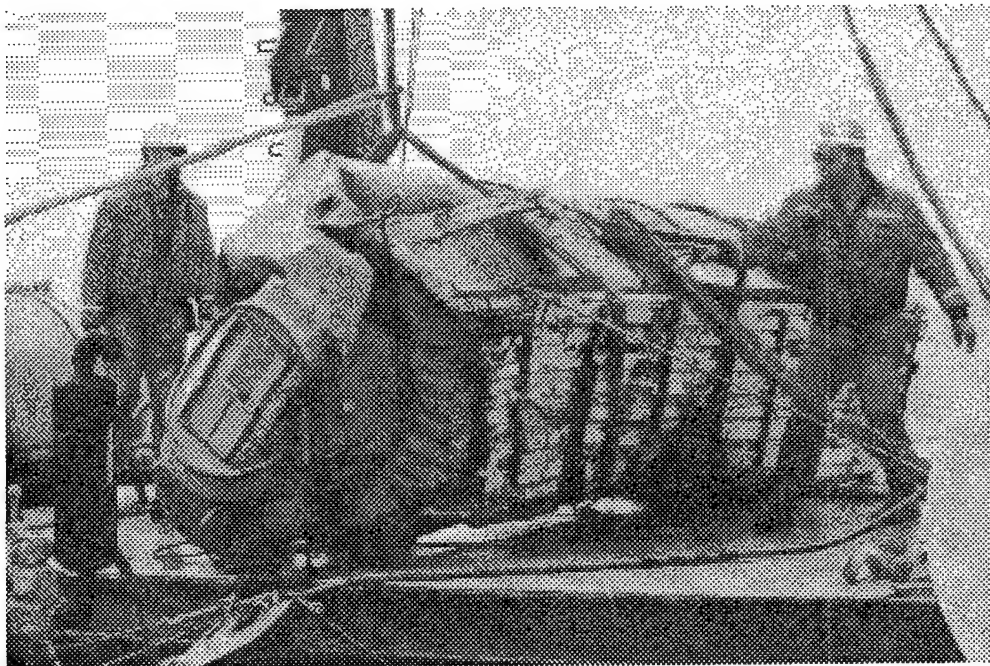
2.2.4.2 Right Fuselage Tank – External & Internal Inspection. All the fuel foam in the right fuselage tank was removed to facilitate an internal inspection. Samples of the charcoal-colored foam from this tank was removed and visually examined. In addition, these samples were sent to ASC/ENF for further examination. Nothing unusual was noted. The inside of the tank was fully inspected for the presence of foreign objects and anything else unusual (i.e., extra parts, lost tools, missing parts, excessive corrosion, improperly installed parts, etc.). The fuel supply lines, that is the lines and check valves from the pumps to the top of the tank, were found to be properly installed and unobstructed. All three check valves in this fuel supply manifold were installed properly and their flappers operated easily. The supply and return lines for the ejector pump were installed correctly. The check valve in the ejector pump pick-up line was installed correctly and its flapper operated easily. Neither the supply line, return line, nor the pick-up line for the ejector pump were obstructed. The only thing unusual noted in this tank was the presence of the gravity fill tube below the gravity fill port and the presence of the impingement cage around the refuel

valve. The presence of these items would not adversely affect tank performance, but their presence is unusual since these items should have been removed in 1990 via TCTO 1C-130-1329. Nothing else unusual was noted.

RT Fuselage Tank on Deck of M/V Independence

RECOMMENDATION: WR-ALC/LB direct a one-time inspection of all fuselage tanks to ensure proper completion of TCTOs and check for corrosion and presence of foreign objects.

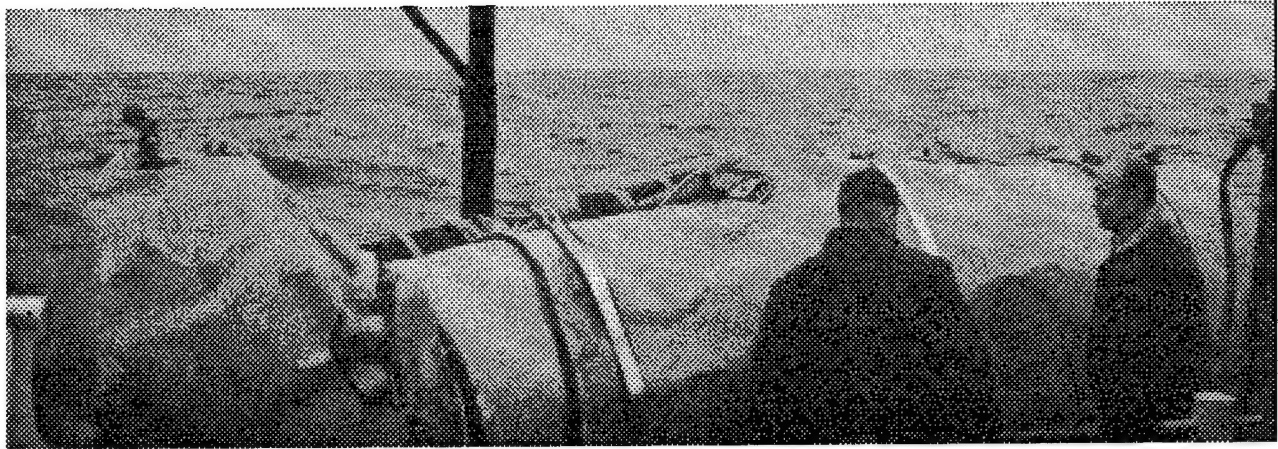
2.2.5.2 Left Fuselage Tank -- External & Internal Inspection. All the fuel foam in the left fuselage tank was removed to facilitate an internal inspection. Samples of the charcoal-colored fuel foam from this tank were removed and visually examined. In addition, these samples were sent to ASC/ENF for further examination. Nothing unusual was noted. The inside of the tank

was fully inspected for the presence of foreign objects and anything else unusual (i.e., extra parts, lost tools, missing parts, excessive corrosion, improperly installed parts, etc.). The fuel supply lines, that is the lines and check valves from the pumps to the top of the tank, were found to be properly installed and unobstructed. All three check valves in this fuel supply manifold were installed properly and their flappers operated easily. The supply line to the ejector pump was installed correctly except for one loose (i.e., finger tight) B-nut. The return line from the ejector pump was installed correctly. The check valve in the ejector pump pick-up line was installed correctly and its flapper operated easily. Neither the supply line, the return line, nor the pick-up line for the ejector pump were obstructed. However, two unattached metal plates (P/Ns 8614271-14) were found near the inlet for the ejector pump pick-up line. The tank's fuel foam trapped the plates against the tank wall where they were rendered harmless. Nothing else unusual was noted.

LT Fuselage Tank on Deck of M/V Independence

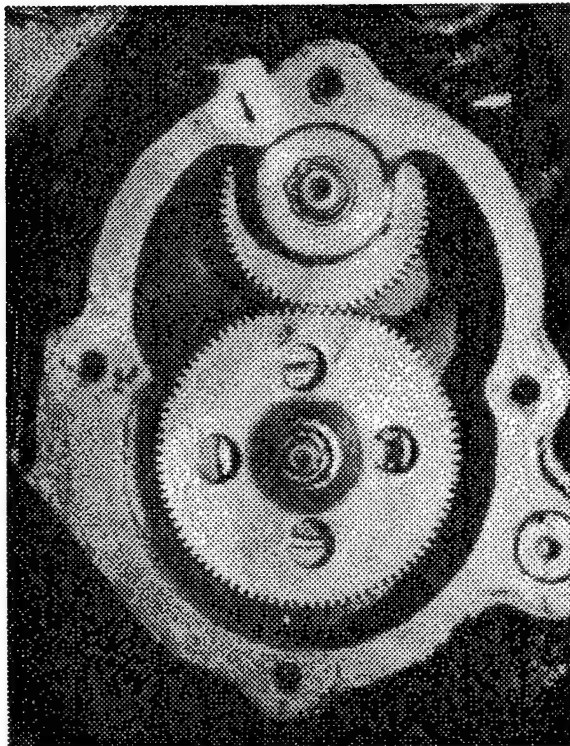
technicians verified the proper alignment of the metering valve drive gears from previous overhaul marks on these gears. The gears indicated that the TD Valve was in a "put" condition at the time electrical power was lost. The remainder of the TD Valve was disassembled and inspected for abnormalities. None were noted.

TD Valve from #1 Engine, in a slight "PUT" Position

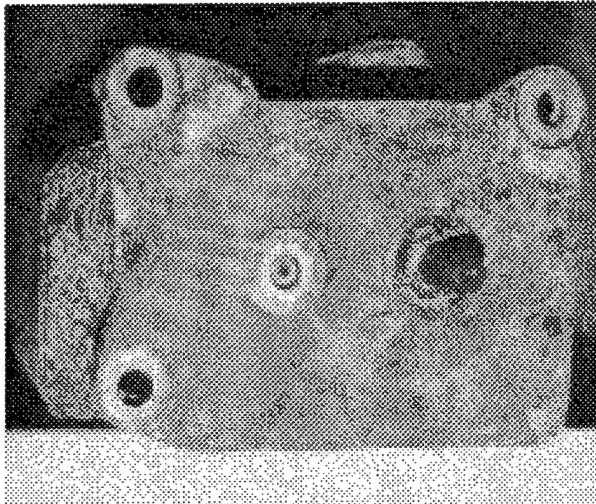
Fuel Shutoff Valve Motor #1 in "close" Position

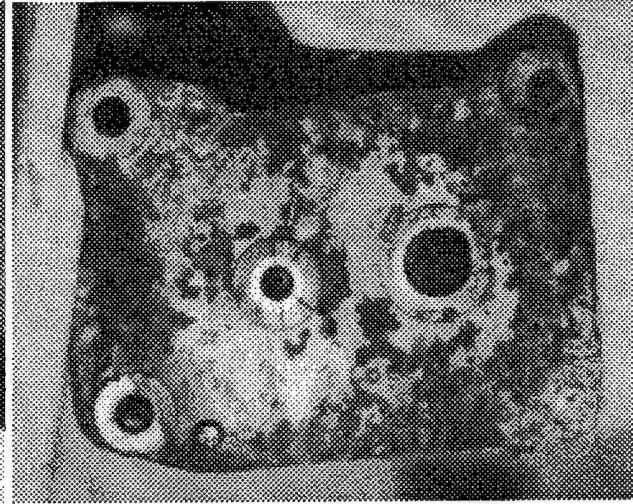
Fuel Shutoff Valve Motor #3 in "open" Position

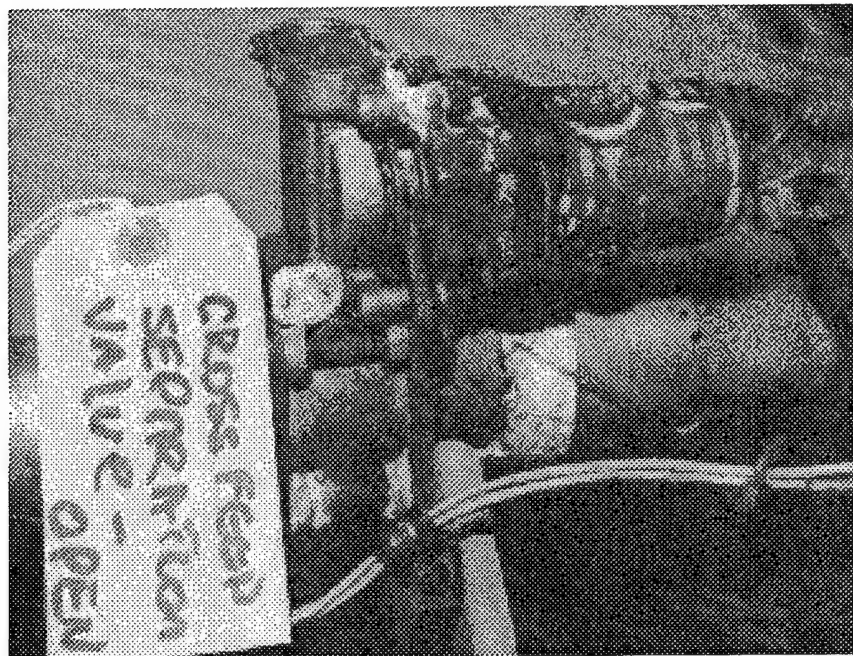
Crossfeed Separation Valve - Found Open

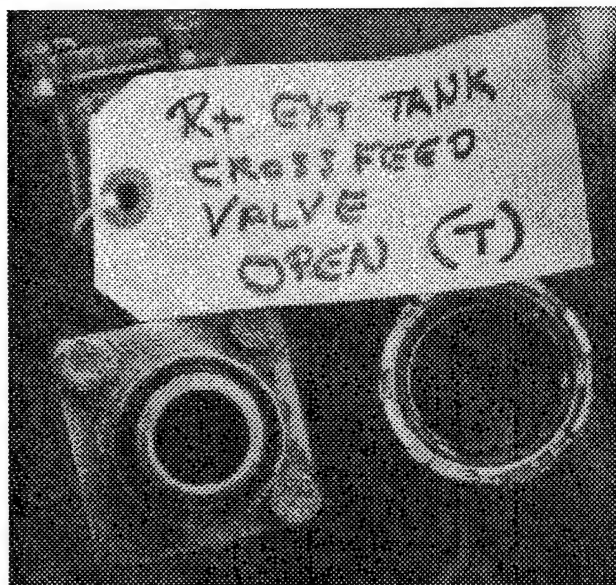
Right External Crossfeed Valve - Found Open

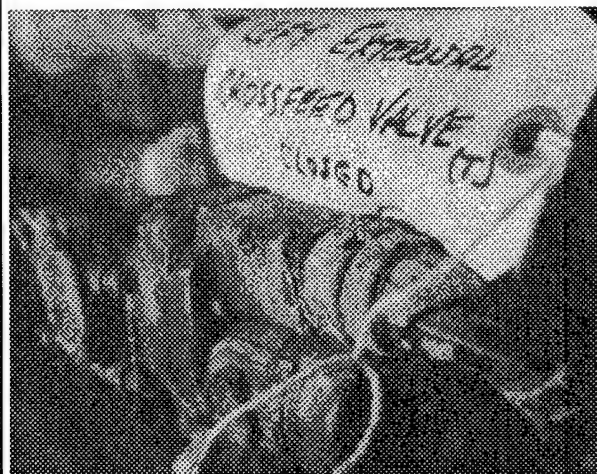
Left External Crossfeed Valve - Found Closed

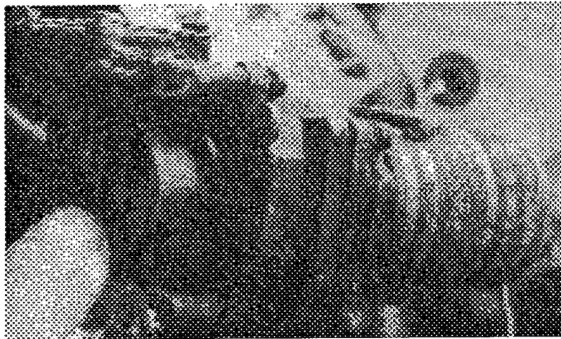
Right Auxiliary Crossfeed Valve – Found Closed

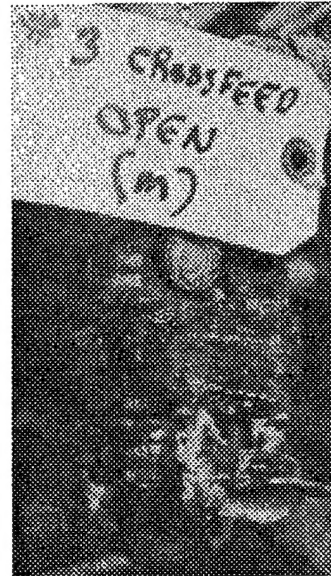
#3 Crossfeed Valve – Found Open

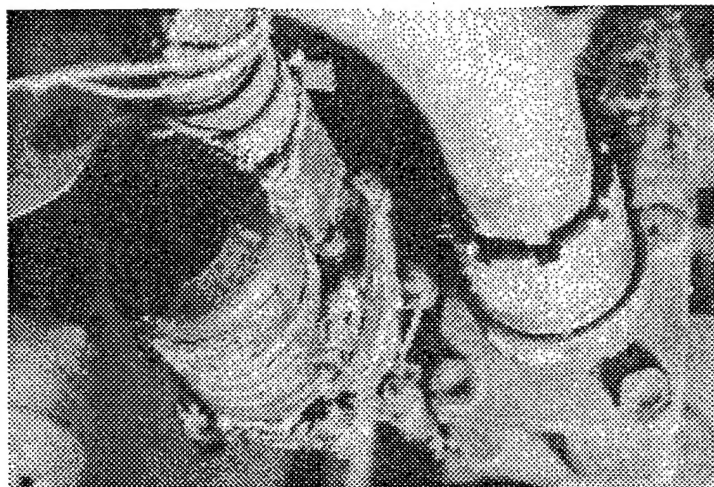
Left Auxiliary Crossfeed Valve – Found Closed
